BELL AEROSPACE TEXTRON BUFFALO N Y  
LACV-30 AUXILIARY POWER UNIT INVESTIGATION.(U)  
JUN 77 R P KAISER  
7467-927024

LACV-30 AUXILIARY POWER UNIT INVESTIGATION

Final Technical Report for Period September 1976-January 1977

This report documents the results of an intensive investigation to determine the cause of a series of T-62T-32-3 engine failures in the Auxiliary Power Unit (APU) on the LACV-30 vehicles, and to develop a solution to the problem.

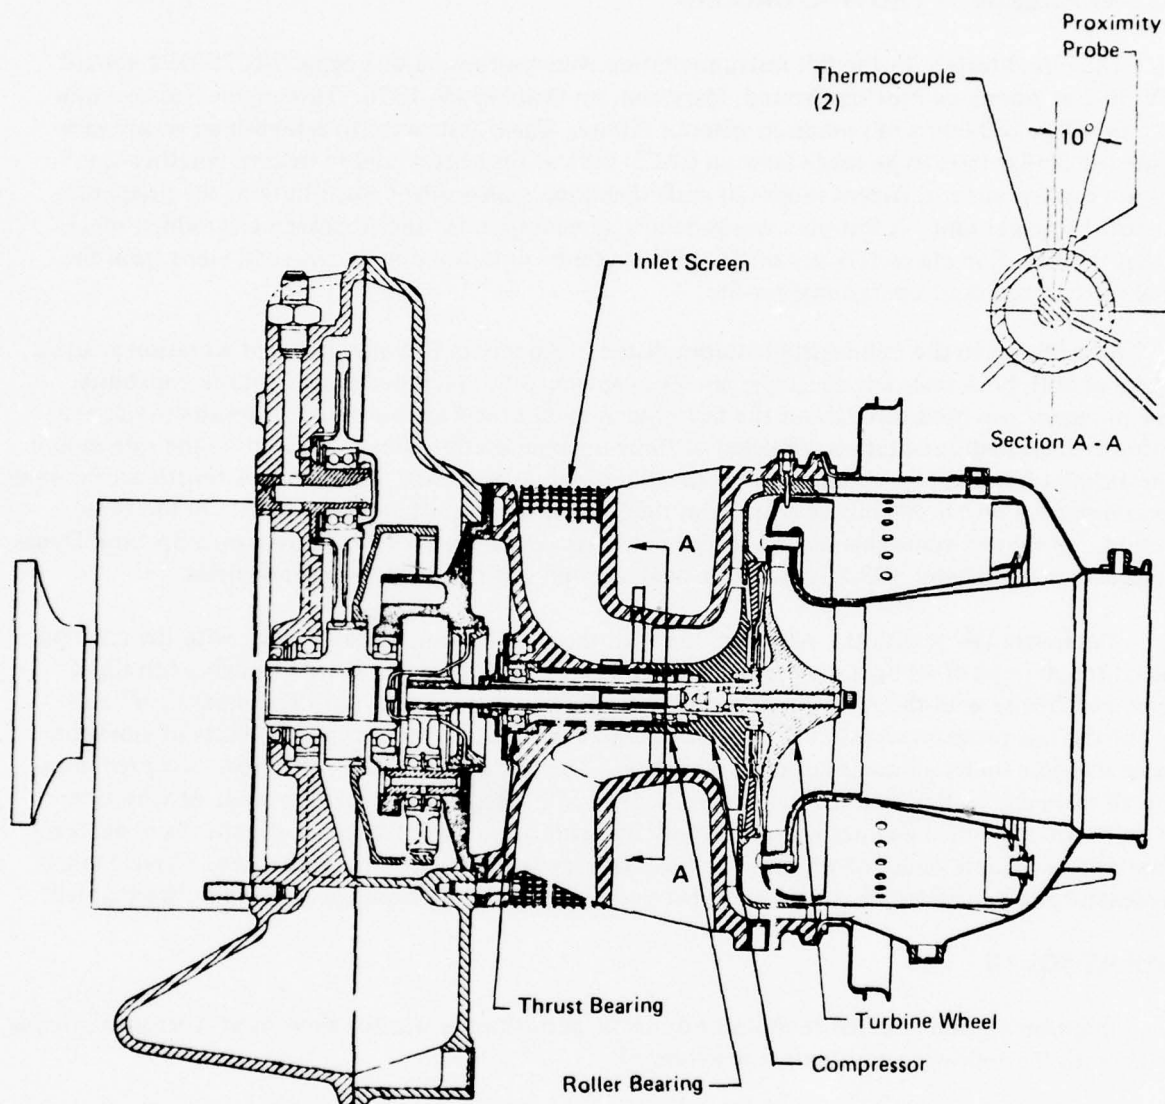
Figure 4. Internal Engine Instrumentation for Tests

Instrumentation selected to monitor dynamic performance was the same as at Aberdeen Proving Ground with the following additions (see Figure 4):

1. **Roller Bearing Temperature Thermocouples.** These were installed in duplicate through the bearing support shoulder with the bead preloaded against the bearing race. The thermocouples were J-type (iron-constantan) 0.06-inch diameter magnesium-oxide-packed, metal-sheathed leads secured with tack-welded stainless foil.
2. **Shaft Orbit Proximity Probes.** Two probes were installed through the outer wall of the air inlet housing to sense movement at the end of the aluminum structure of the bearing support column just ahead of the impeller.
